#### **What are the 4 "big killers" of turbochargers?** (excerpt from our official training program)

- 1) Oil Contamination
- 2) Lack of lubricaiton
- 3) Foreign object damage
- 4) Exceptional operating conditions

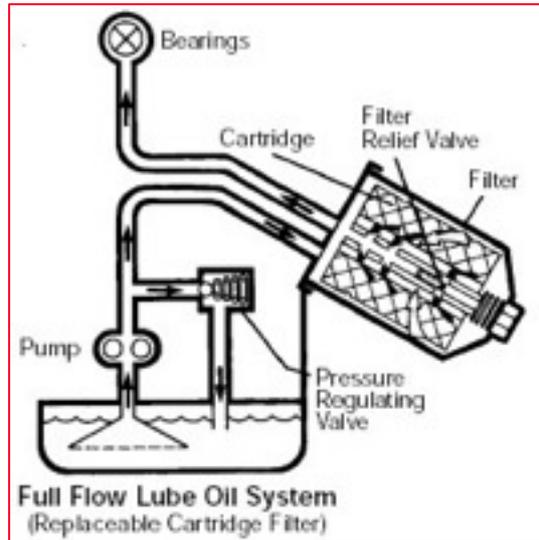
**Air trapped in pickup tube causing cavitation of pump and lack of oil flow**

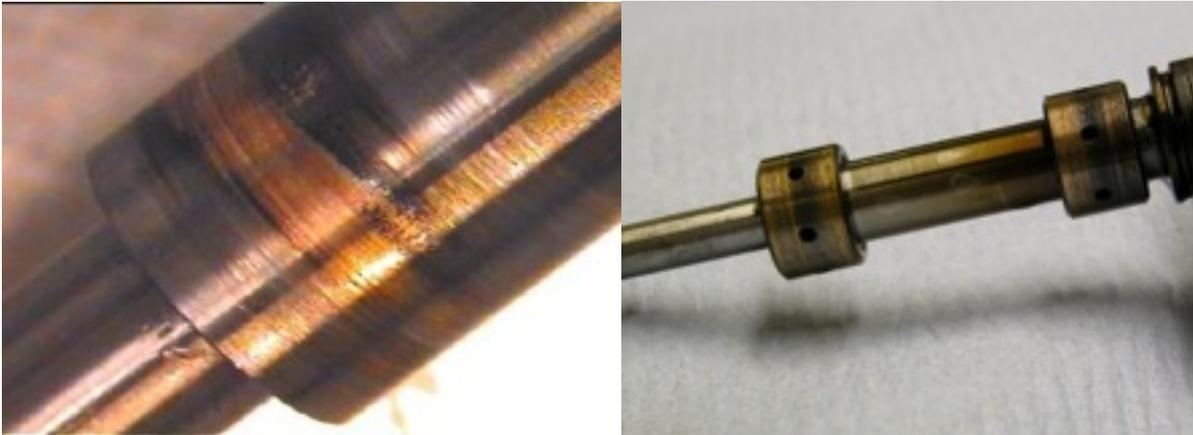
The average passenger vehicle turbocharger (petrol or diesel) rotates around 7000 - 100000RPM at engine idle speed, vehicle dependant. At this speed a 10mm turbine shaft rotating inside a bronze rotational bearing is covering 5.23 meters a second - remove the oil, and the result is a a thermal overload, causing what we term in metallurgical terms "Material Transfer" also known as a seizure. This is clearly visible and depicted as a bronze discolouration on the shaft. What occurs inside the bearing system is simply the thermal ceiling of the bronze bearing reaches its ceiling (maximum temperature) before the hardened steel shaft, and "swipes" itself into the steel shaft.

This "swiping" effect is bearing material being removed and "smeared" onto the shaft or thrust collar/spacer etc, the clearance (oil gap) between the shaft and bearing will then increase as a result, and will continue to do so (even if the lubrication to the bearing is restored) until there is enough clearance between the rotating components to allow the wheels to make contact with the end housings. The immediate reaction by the customer and installation mechanic is that the turbo was supplied with faulty bearings form the factory or the product is a poor quality product. This is not the case at all, as every turbocharger in the same batch would then be faulty.

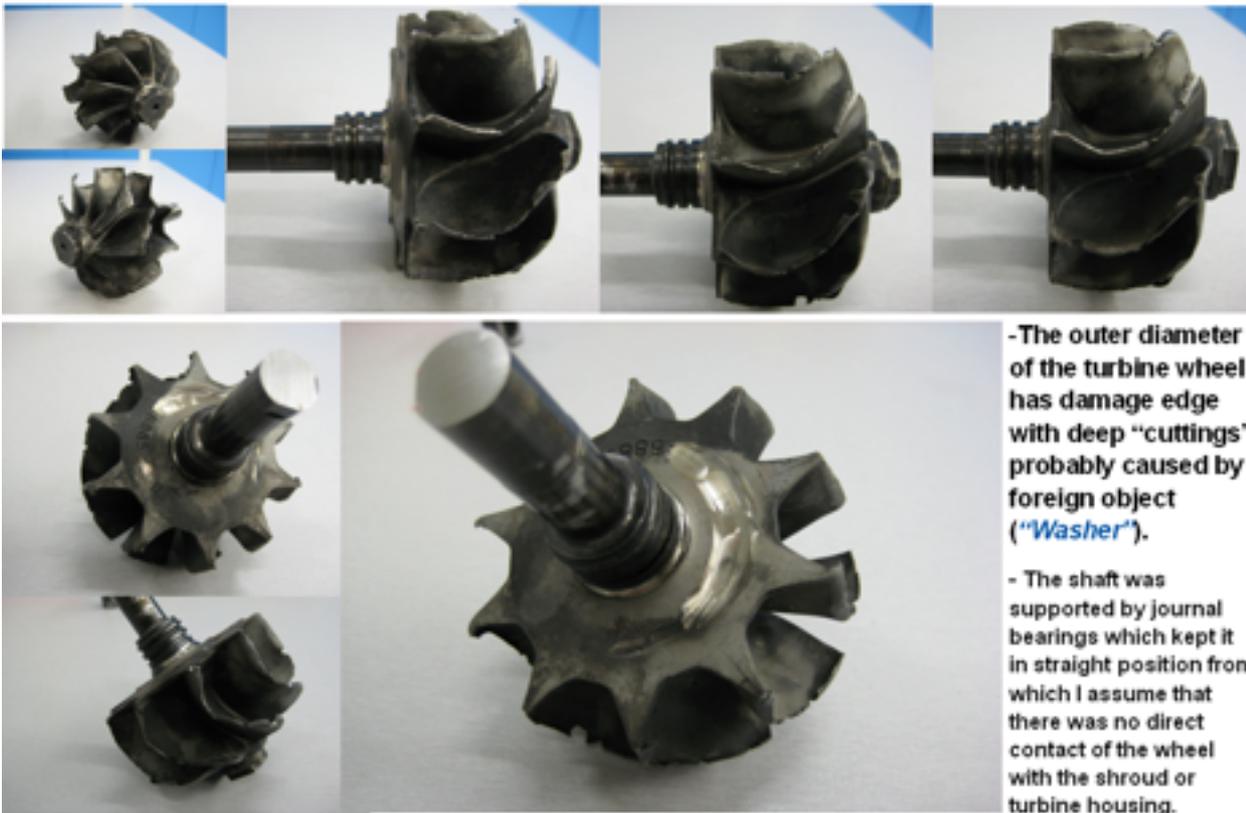
Although FOD on the turbine side is the least common of the two, it does happen. This can clearly be seen by bent turbine wheel inducer blades. In almost all cases, it is argued that the turbocharger supplied was faulty or of poor quality, however once again facts are clearly visible by the bent/damaged blades. Keeping in mind that the turbine and compressor wheels make no contact with any component during normal operation, it is not possible for either of these wheel's blades to simply bend or become damaged without something coming into contact with them. Other causes of FOD on the turbine side are listed as follows

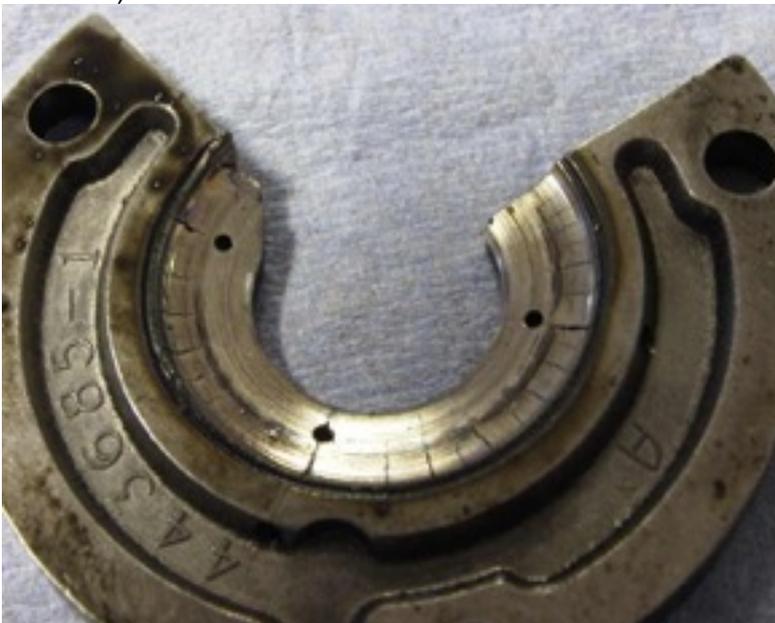
The failure of which usually results in either a thrust assembly failure and/or compressor/turbine burst. In the cases where the thrust fails first, clear signs of a metallurgical term known as “orange peel” can be seen on the compressor wheel base (showing a deformation of the materials structure)

This can be confirmed with metallurgical equipment in the form of a scanning electron microscope and other equipment. Deformation of the turbine wheel base will also be visible and clearly depicted with the use of a shadow graph machine.

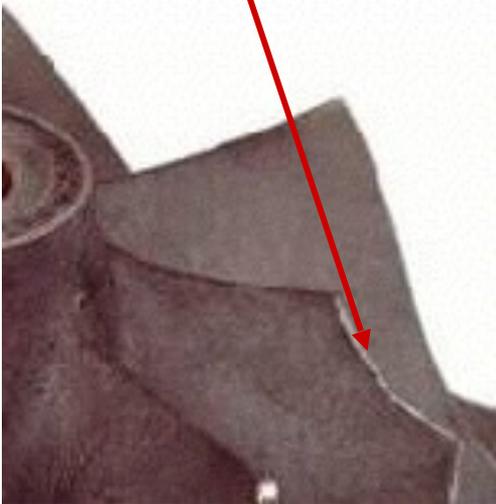
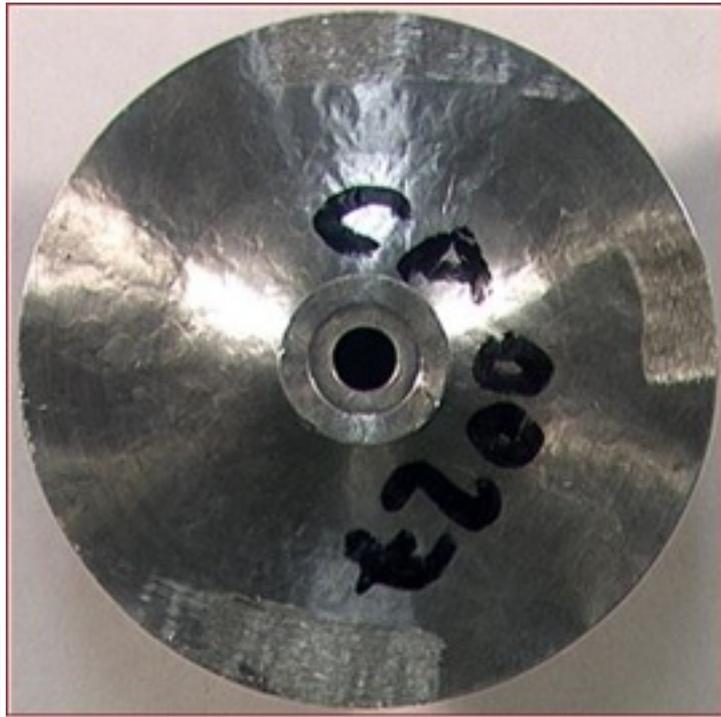
**Only part of blade  
broken, typical of  
overspeeding**
