#### **What are the 4 "big killers" of turbochargers?** (excerpt from our official training program)

- 1) Oil Contamination
- 2) Lack of lubricaiton
- 3) Foreign object damage
- 4) Exceptional operating conditions

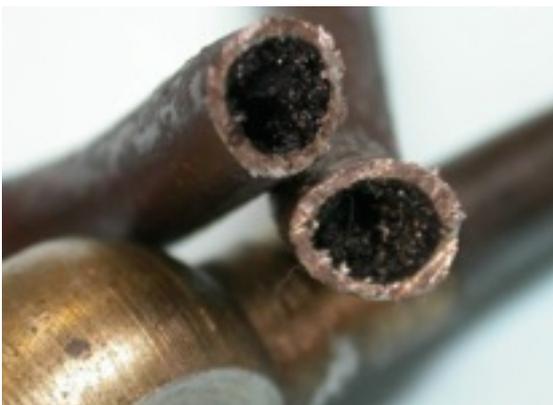
easy to identify, but difficult to locate the cause. Once again due to the complex oil supply system inside the engine and through the turbo feed line, determining the exact cause of the oil blockage is difficult and can be one or more of many possible components on the engine. The following is a list of possible causes of lack of lubrication.

- Faulty oil pump
- Blocked oil pickup
- Sludge buildup in the oil pump
- Sludge buildup inside the sump
- Low oil level
- Blocked oil feed line
- Kinked or bent oil feed line

- Contaminated/carbon filled oil feed line
- Sludge buildup lodged inside the turbocharger's oil passageways
- Use of oil additives which causes "caramelisation" of the oil, blocking passageways
- Other

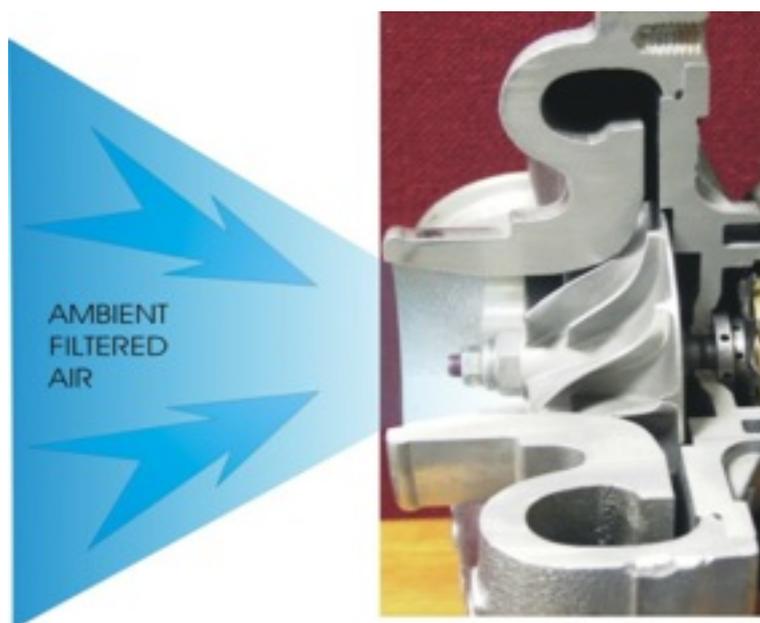
**Foreign object damage:**

Lets talk about foreign object damage. Otherwise known as "FOD" this is the quickest failure to identify, however in some cases very difficult to locate the primary mechanism associated with the failure itself. FOD can occur on two possible entries to the turbocharger. One on the turbine side, and the other on the compressor side. The inlet to the turbine side of the turbocharger is through the exhaust manifold, via the turbine housing and directed straight into the turbine wheel inducer. The opposite compressor side draws air in through the air filter, and into the compressor housing inlet, directly to the inducer of the compressor wheel.

On the turbine side, there is no filter between the engine and the turbine wheel inducer. On the compressor side, the only component protecting the aluminium made, compressor wheel is the engines air filter. If this air filter is old, damaged, or of the incorrect grade, debris will be allowed to

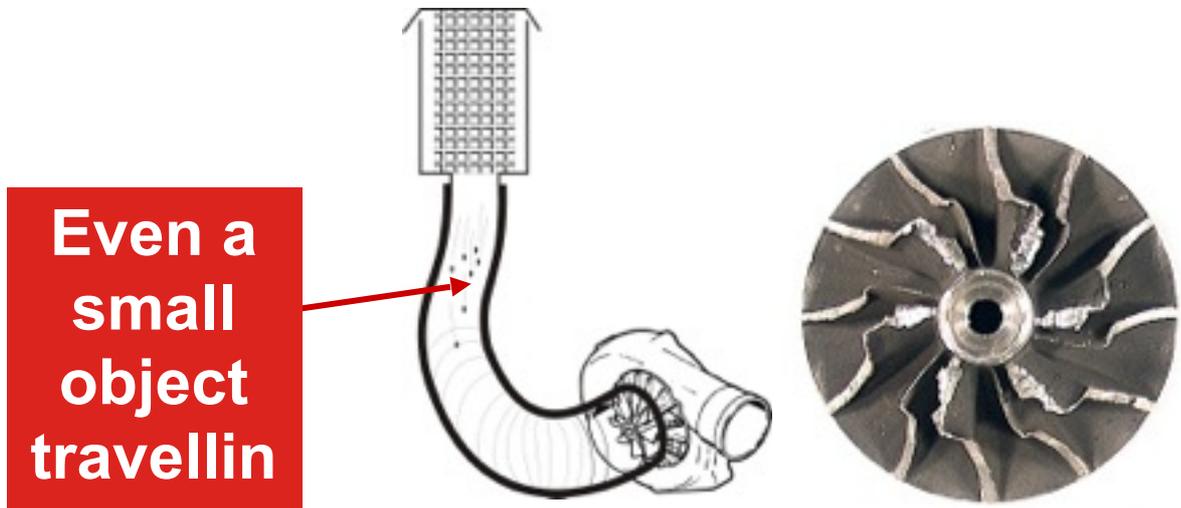
- Incorrect air filter grade or Cone filter upgrade
- No air filter
- Old/Damaged air filter
- Damaged/cracked Air intake tract
- Breather related pipes connecting to external components which might be damaged
- Faulty/Damaged EGR valve
- Other

On the turbine side, manifolds crack over time, and pieces break off with extensive use. These pieces are routed directly into the turbine wheel inducer and cause damage to the turbine wheel blades. Often during removal and re-installation of a failed turbocharger, mechanics either leave rags inside the manifolds, or loosen old fasteners from the turbocharger, and sometimes these snap off and small pieces of the broken fastener fall into the manifold unbeknown to the mechanic.

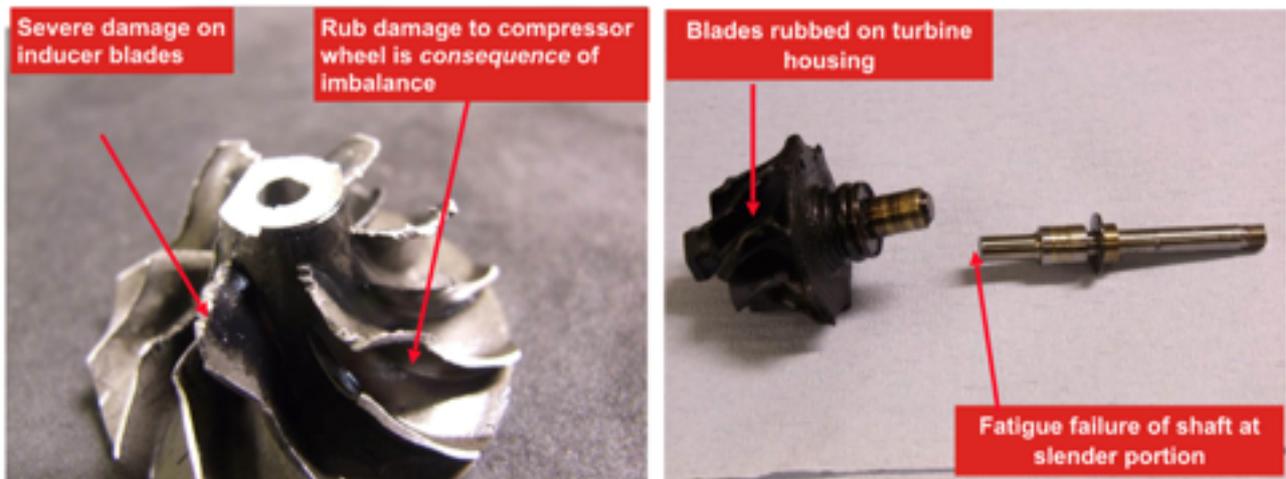
Once the new turbocharger is fitted, the engine is started and the exhaust gasses deliver these foreign objects straight into the turbine wheel blades. Failed engines or engines with dropped valves or other similar failures/problems will also cause similar FOD.

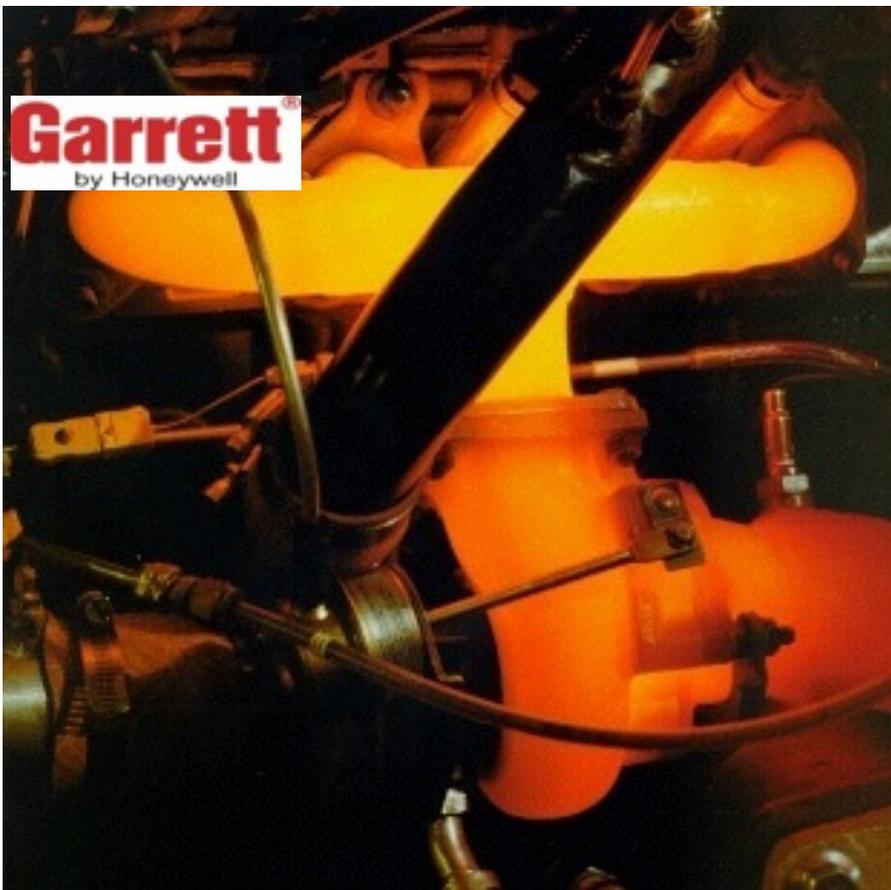
It is easily detectable from inspecting the turbocharger, and verified through metallurgical analysis of the materials and other components inside the turbocharger. In most cases over boosting (chip tuning, race chips, tuning boxes etc) installed onto the vehicle will increase both fuel pressure, injection timing, and obviously boost pressure. Increasing boost pressure increases the rotating speeds of the turbocharger. As it is, the normal operating speeds of a turbocharger found in a passenger vehicle is 100 000RPM PLUS. In some cases we have seen rotational speeds close to 240 000RPM which far exceed the maximum tolerance for the turbochargers intended purpose and design.

The failure of which usually results in either a thrust assembly failure and/or compressor/turbine burst. In the cases where the thrust fails first, clear signs of a metallurgical term known as “orange peel” can be seen on the compressor wheel base (showing a deformation of the materials structure)
